EXHIBIT W

Materials Characterization of Explanted Polypropylene Hernia Meshes

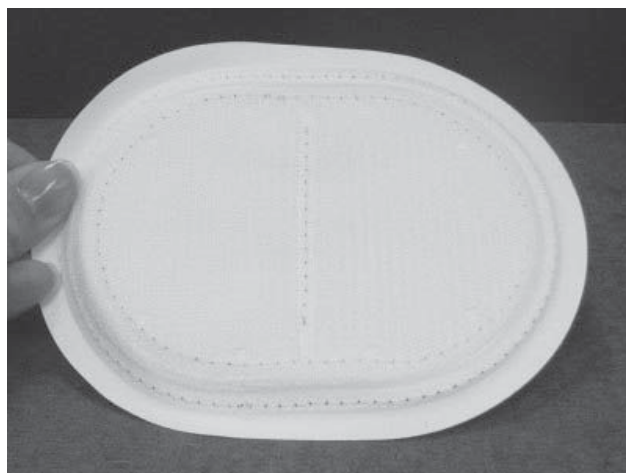
Figure 2. Pristine Kugel Composix hernia mesh.
